Quantitative Investigation of Surface and Subsurface Fatigue Cracks Near Rivets in Riveted Joints Using Acoustic, Electron and Optical Microscopy

**Quantitative Investigation of Surface and Subsurface Fatigue Cracks Near Rivets in
Riveted Joints Using Acoustic, Electron and Optical Microscopy**

A DISSERTATION

DOCTOR OF PHILOSOPHY

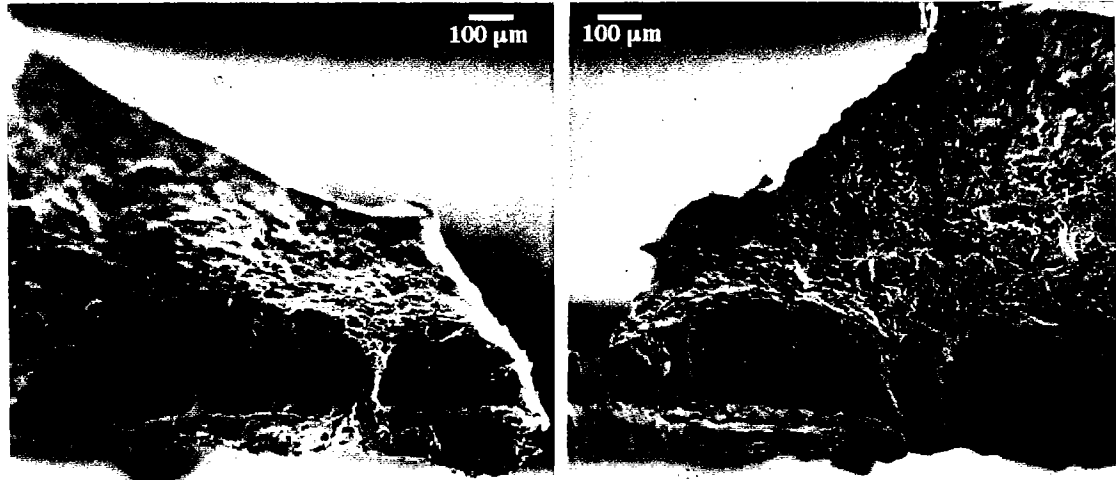
Fig. 4.24. Scanning electron micrograph of the fracture surface of the specimen on which the C-scan was taken in Figure 4.23. Multiple initiation sites are seen on each side of the rivet.

A SAM C-scan showing a barely visible crack formed at a maximum nominal stress of 103 MPa is shown in Figure 4.23. This crack had just emerged from under the rivet head but was below the outside surface. No rumpling was seen on the outside surface. The fatigue fracture surface is shown in Figure 4.24, a scanning electron micrograph of the fracture surface. The fatigue crack on the right is the one imaged in Figure 4.23. It has extended about 500 μm beyond the top of the chamfer and rivet head and has its maximum length on the hidden surface of the chamfered panel. The crack on the left side, clearly visible in the fractograph, has not yet emerged from under

the rivet head and was not seen by the SAM. The fracture surface of this specimen exposes several fatigue crack initiation sites on each side of the rivet head. The initiation sites for all of these cracks are located on or very close to the hidden surface some distance from the rivet. By tilting the specimen and examining it under an optical microscope, these cracks were determined to be shear cracks initially. The initial cracks form along shear bands oriented close to the maximum shear direction.

The initiation sites for specimens fatigued at a maximum applied stress of 103 MPa, as already noted, are located some distance from the blunt knife portion of the rivet hole. (Figures 4.21 and 4.24) When cracks nucleate away from rivet holes in lap joints, this is an indication that they were likely caused by fretting (Forsyth, 1981; Beard, 1988; Hoeppner, 1994; Müller, 1995; Fawaz, 1997) as opposed to cracks initiating at the centerline of the rivet hole as is expected since this is where the stress intensity factor is the greatest for a countersunk hole. In results reported by Piascik et al. (1997), fretting was the major cause of crack nucleation in tests performed on a full-scale fuselage. There was a correlation between the degree of fretting and cracking.

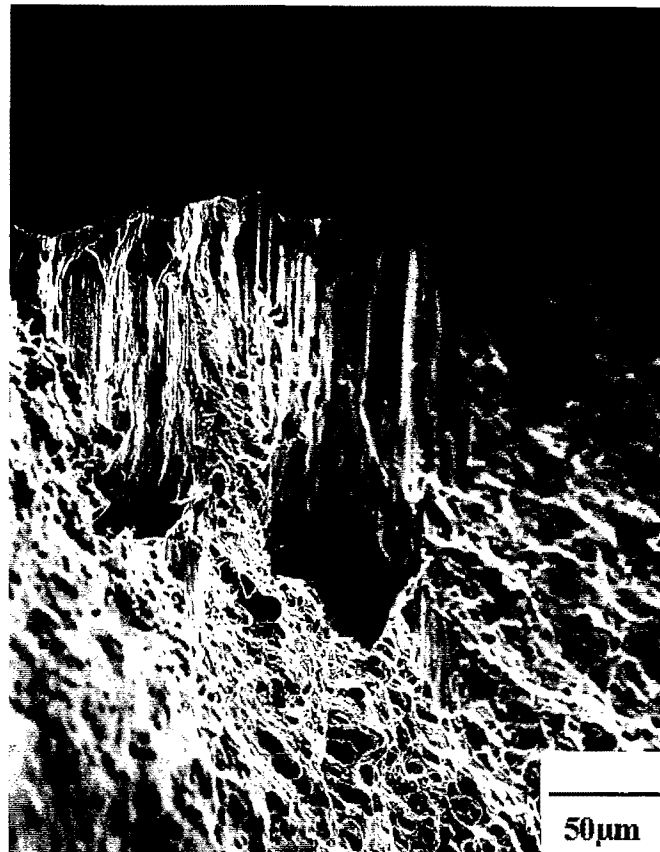
Fig. 4.25a. Shear cracking in a specimen fatigued for a total of 80,000 cycles. The fretted surface is shown at the top of the photomicrograph.

At a very early stage of the fatigue process, shear cracking was observed as seen in the scanning electron micrographs in Figure 4.25a and 4.25b. This specimen was fatigued for a total of 80,000 cycles, and then the rivets were removed. The two sheets had to be pulled apart, which is evidence of adhesion that occurs at early stages of fretting fatigue and promotes crack initiation. No cracks were seen with the SAM, when the fatigue cycling was stopped.

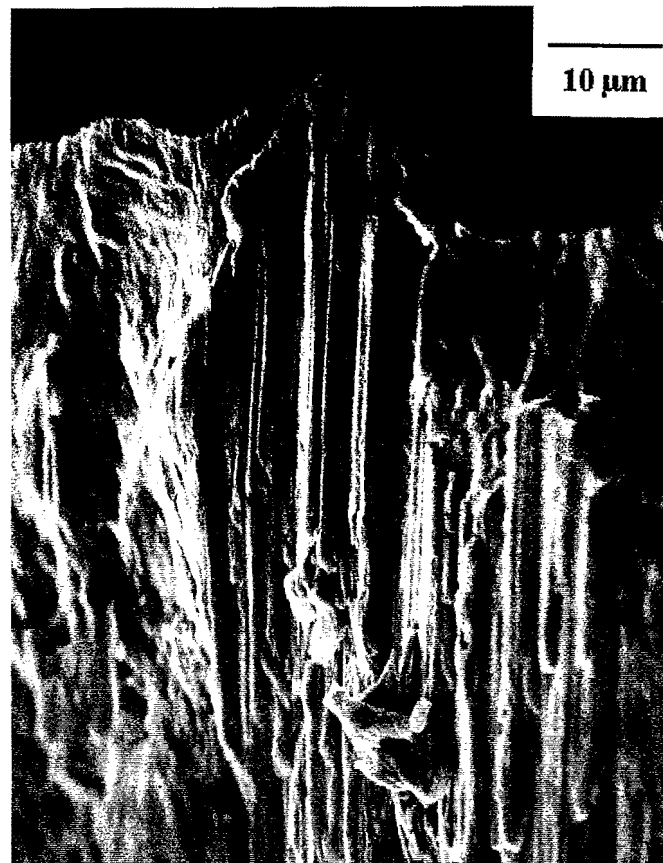
Fig. 4.25b. Shear cracking on same specimen as Fig. 4.25a at a higher magnification. Note planar stepped fracture surfaces.

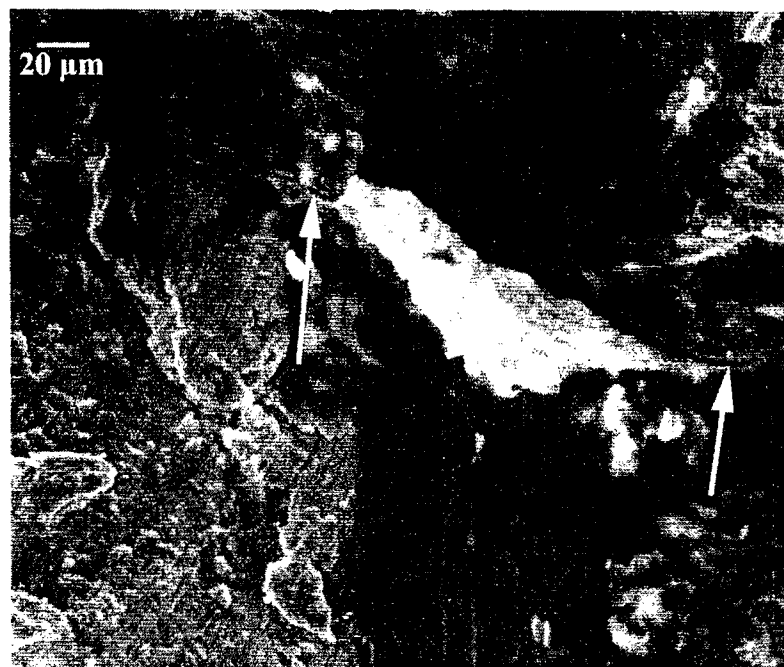
Fig. 4.26. White particle with cracks emanating from the tips and embedded in the fretted surface of a specimen. (80,000 cycles)

the delamination and may have contributed to the crack formation by fretting pit formation. Electron Dispersive X-ray (EDX) analysis revealed only aluminum in the wear particles. As the particles are quite bright due to charging in the SEM current, this is an indication that the particles are not conductive. Since the SEM cannot detect oxygen, it is concluded that the wear particles are a non-conducting compound, no doubt Al_2O_3 . The white embedded particle in Figure 4.26 is an example of this. A crack is seen emanating from the tips of this particle as pointed out by the arrows. In Figure 4.27, a wear particle that is just beginning to break away from the substrate is observed. Another example of this with the wear particle at a later stage in the erosion process is given in Figure 4.28.

fatigue cracks are typically where there is a stress concentration. As mentioned above, both pits and embedded particles are sites of stress concentration. Evidence of this is shown in Figure 4.26 where an embedded particle has cracks emerging from both ends of the particle. Wear particles that are breaking away from the substrate are observed in Figures 4.27 and 4.28. Wear particles are seen at or near initiation sites in Figure 4.18 and Figure 4.29. Black particles are seen on the fayed surfaces at Rivet 3. As already mentioned, analysis of wear particles with EDX analysis indicated that they were Al_2O_3 . Also as already mentioned, the delamination of the Alclad layer from the 2024 alloy was observed. This could result in fretting pit formation. Additionally, the soft aluminum cladding is easily scored by hard oxidized wear particles.

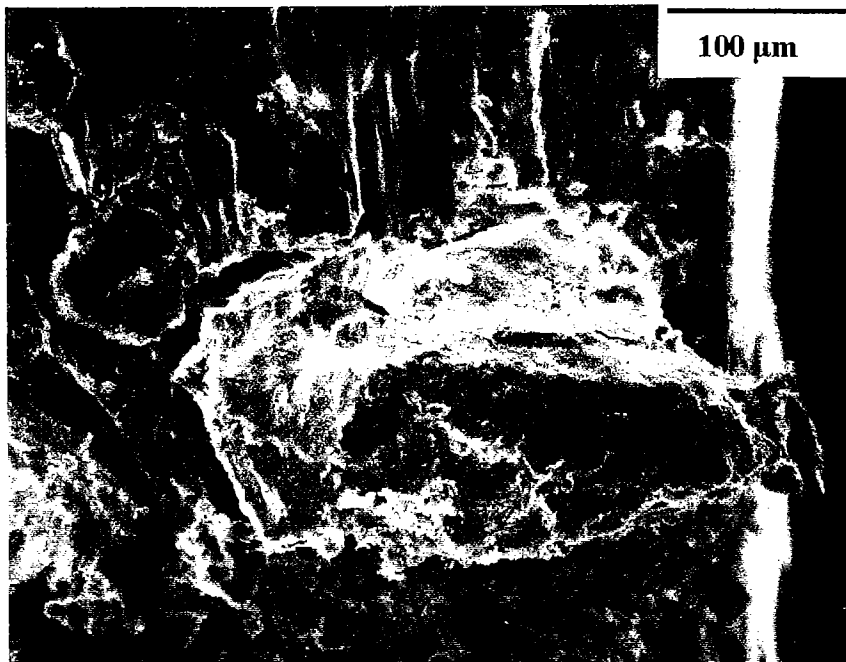
Fig. 4.27. Wear particle beginning to break away from the substrate. (3600 cycles)

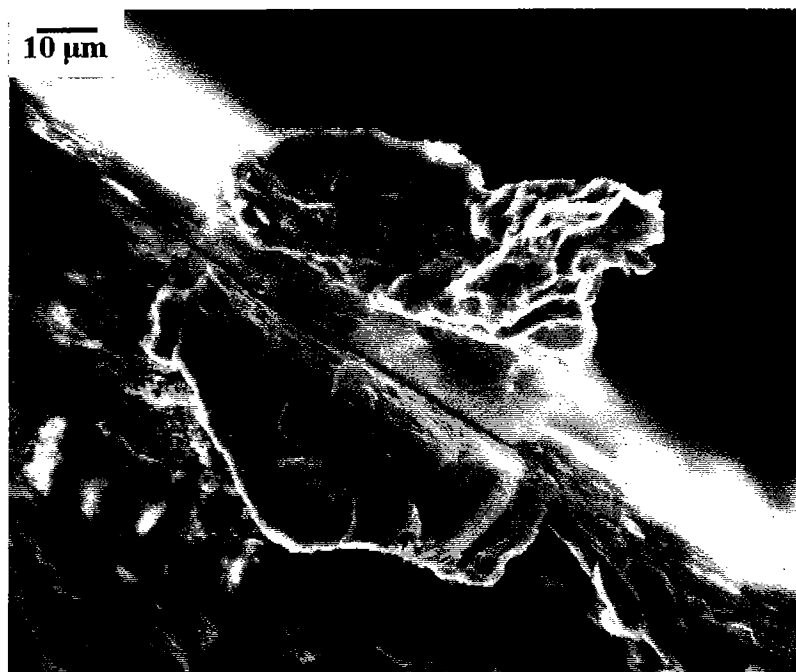
Fig. 4.28. Wear particle at a later stage in the erosion process. (80,000 cycles)

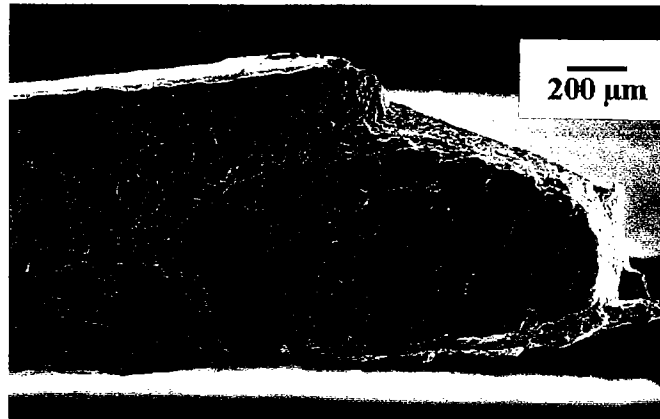
Fig. 4.29. Photomicrograph of the fracture surface of a specimen showing an embedded wear particle at or near the initiation site of one of the cracks. Several microcracks have linked up to form one macrocrack. (240,000 cycles)

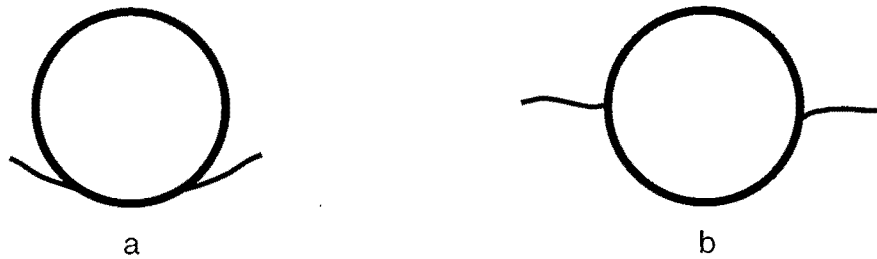
Fig. 4.30. a) Sketch showing an eyebrow type crack b) Sketch showing a centerline type crack

When specimens were fatigued at a maximum nominal applied stress of 103 MPa and an R ratio of 0.1, as already discussed, “eyebrow” type cracks formed. When the maximum nominal applied stress was increased to 154 MPa or higher, a diametral radial crack formed. (A similar behavior was noted on stress increase with seven rivet specimens). These are schematically shown in Figure 4.30 and the two kinds of cracks are shown in the C-scans in Figures 4.31 and 4.32. The former was fatigued at 103 MPa nominal stress for 205,000 cycles. The end-to-end crack length is 8.1 mm. The

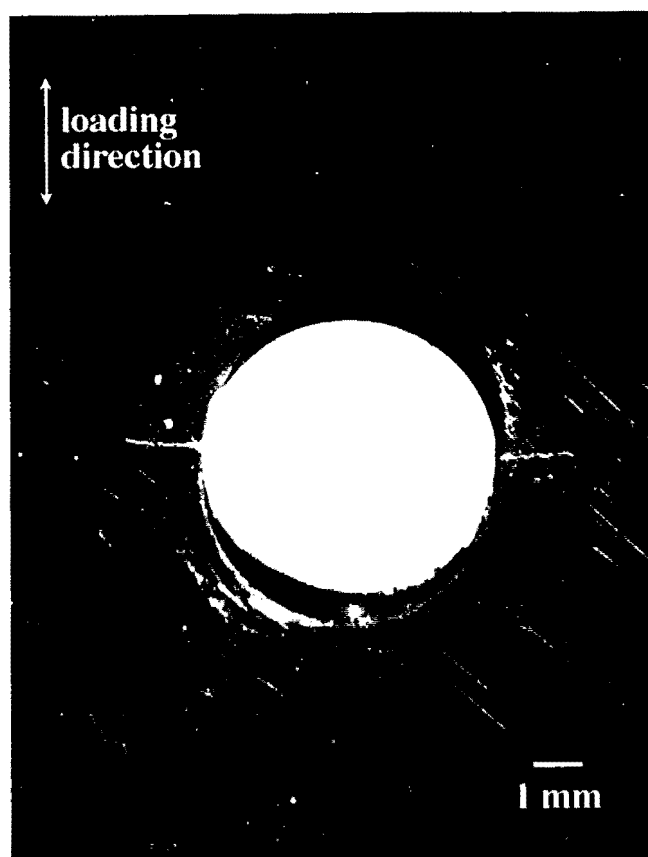
Fig. 4.33a. Optical micrograph of the front surface of a specimen that has a centerline type fatigue crack. This specimen was fatigued at a maximum nominal applied stress of 206 MPa and an R ratio of 0.1. (800 cycles)

Figure 4.33a is an optical micrograph of the front surface of a specimen fatigued at a maximum nominal applied stress of 206 MPa for 900 cycles. The centerline crack is clearly visible. The micrograph shows that at this high load the rivet is beginning to pull out and that there is competition between the specimen fracturing due to the fatigue crack or the specimen failing due to the rivet pulling out. These observations are important, because the fuselage of an aircraft will experience higher stresses as cracks grow resulting in the cross sectional area decreasing so the stress is higher at adjoining rivets. Figure 4.33b is a micrograph of the damaged surface of the same specimen as

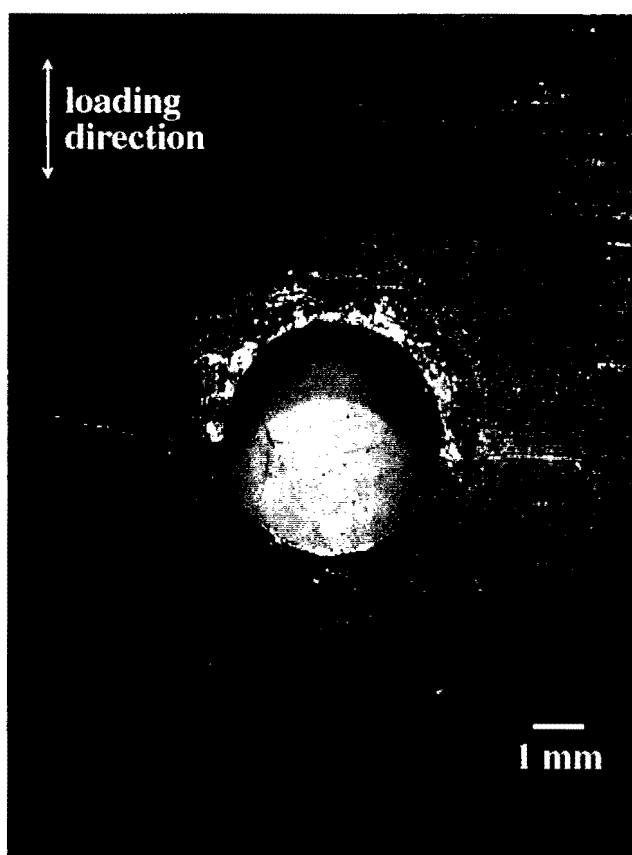
Fig. 4.33b. Optical micrograph of the damaged surface of the specimen shown in Figure 4.33a. Note that the area surrounding the bottom half of the rivet appears to be relatively free from damage. (800 cycles)

different levels of stress. At 103 MPa, a great deal of fretting damage is seen around the entire rivet hole (Figure 4.14) while little fretting damage is seen around the bottom of the rivet hole at 154 MPa (Figure 4.33b) When fretting occurs around the entire rivet hole, this indicates fretting is the primary cause of fatigue rather than the stress concentration at the hole. [Forsyth, 1981] At the higher stress of 154 MPa, crack nucleation results *primarily* due to the stress intensity factor at the centerline of the rivet hole.

shown in 4.33a focused on the panel and reveals that the area surrounding the bottom half of the rivet hole appears to be relatively free from damage. The end-to-end centerline crack length as measured in the acoustic C-scan is about 10.0 mm. When the end-to-end crack length was measured optically, it was about 9.2 mm, so the crack at this length is longer than measured on the outside surface of the chamfered panel. As already discussed, similar behavior is seen for short eyebrow type cracks. The maximum bending stress due to the bending moment in the riveted specimen is on the back surface of the countersunk panel at the rivet head of Rivet 3 resulting in the visible surface being in compression and the fayed surface being in tension as already discussed. This is one source for the cracks being longer on the fayed surface. The centerline crack is initiated on a subsurface at the knife edge as shown later. In a panel with a chamfered hole, the initiation is also at the knife edge. [Fadragas, 1993]

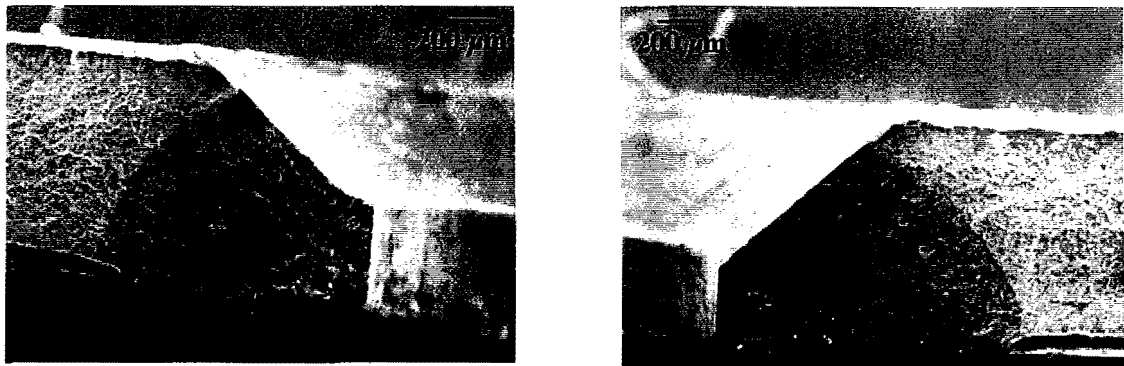
Fig. 4.34. Scanning electron micrograph of the fracture surface of a specimen, which was fatigued at a maximum stress of 154 MPa. (3600 cycles)

Figure 4.34 is a scanning electron micrograph of the fracture surface of a specimen fatigued at a maximum nominal stress of 154 MPa. An enlargement of the blunt knife edge region on the left in Figure 4.34 is shown in Figure 4.35. The figure shows the chamfered region, which is lighter in shading than the fracture surface. The crack in the panel starts as a shear crack near the centerline of the rivet hole and on the fayed surface between the rivet and panel somewhere near or at the blunt knife edge - hidden surface corner. After a very small amount of crack growth, it changes to a mode

I crack. The specimen was tilted 20° in the SEM to more clearly show the shear region and the rivet hole illustrating the change in mode from a shear crack to a mode I crack. The boundary on the fracture surface between shear and mode I has been marked by a dotted white line. The just initiated crack is expected to be a shear crack nucleated by a dislocation process. At 154 MPa nominal stress range, the transition from a shear to a mode I fatigue crack occurs at a very much smaller crack length than at 103 MPa. Both Mode I and mixed mode eyebrow cracks are seen in aircraft skins. Note that the fatigue crack shown in Figure 4.34 has not reached the outer surface and would not be seen by optical examination of the outer surface.

A SAM image of a crack formed at a maximum nominal stress of 154 MPa that has just emerged from under the rivet head is shown in Figure 4.36, and the corresponding fracture surface as viewed with the SEM for this specimen was given in Figure 4.34. While there are cracks on both sides of the rivet, the SAM only indicated the larger of the two.

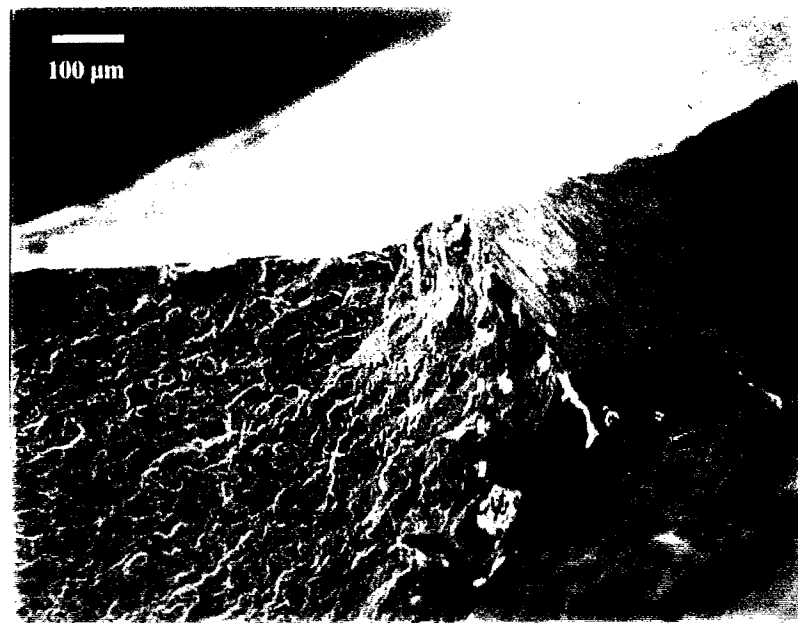
Fig. 4.35. Scanning electron micrograph of the crack on the left side in Figure 4.34. The transition from a shear crack to a crack that is propagating normal to the direction of the applied stress is given by the dotted line. (3600 cycles)

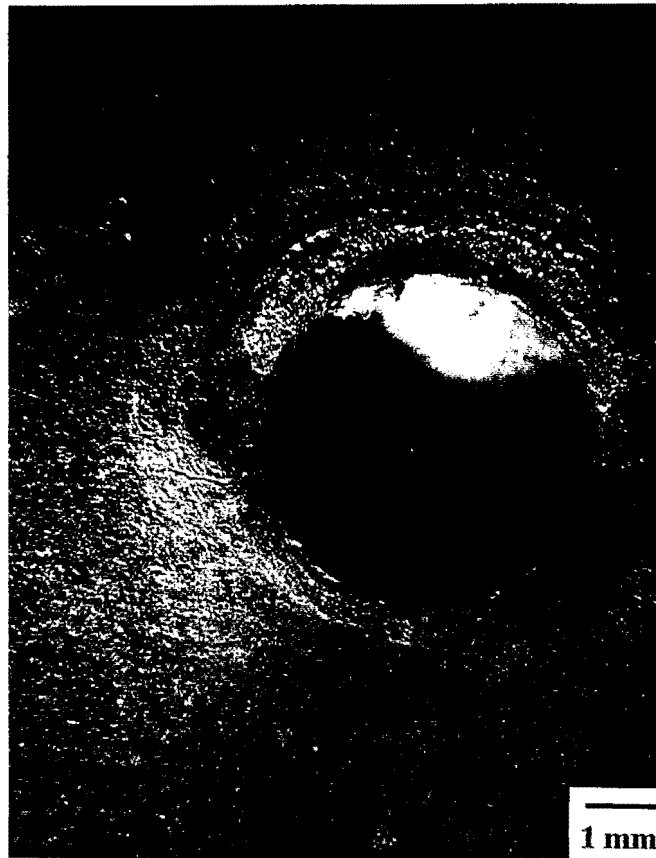
Fig. 4.37. Optical micrograph of the fayed surface of a specimen fatigued at 154 MPa. (3000 cycles)

Figure 4.37 is an optical micrograph of the fayed surface of a specimen fatigued at 154 MPa. A propagating crack is seen emanating from the rivet hole at the boundary between the damaged surface and the surface, which is relatively free of damage. When fretting occurs only on one side of the fatigue crack, Forsyth (1981) concluded that the propagating crack occurred before a major amount of fretting damage has occurred. The figure shown is evidence for this.

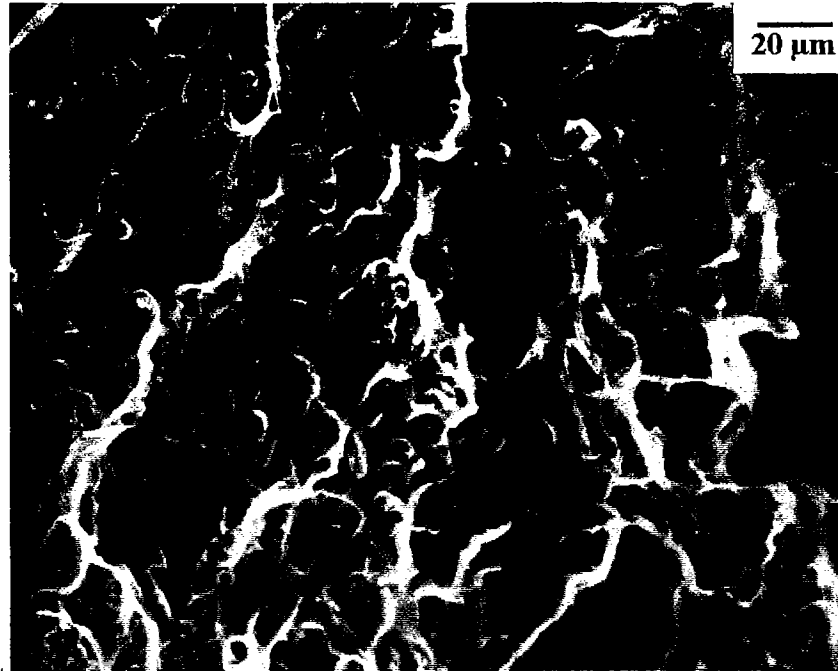
Fig. 4.38a. Optical micrograph showing regions of ductile fracture and fatigue fracture on the fracture surface of a specimen fatigued at a maximum nominal stress of 154 MPa. (3000 cycles)

At the higher nominal stress of 154 MPa, regions of ductile fracture were seen in the fatigue crack area. (Figures 4.38a and 4.38b) This happens when microscopic crack linking occurs as the crack advances. Both photomicrographs in Figures 4.38a and

4.38b are of the same specimen with a higher magnification in Figure 4.38b. Voids, void linking, microcracks as well as fatigue striations are seen.

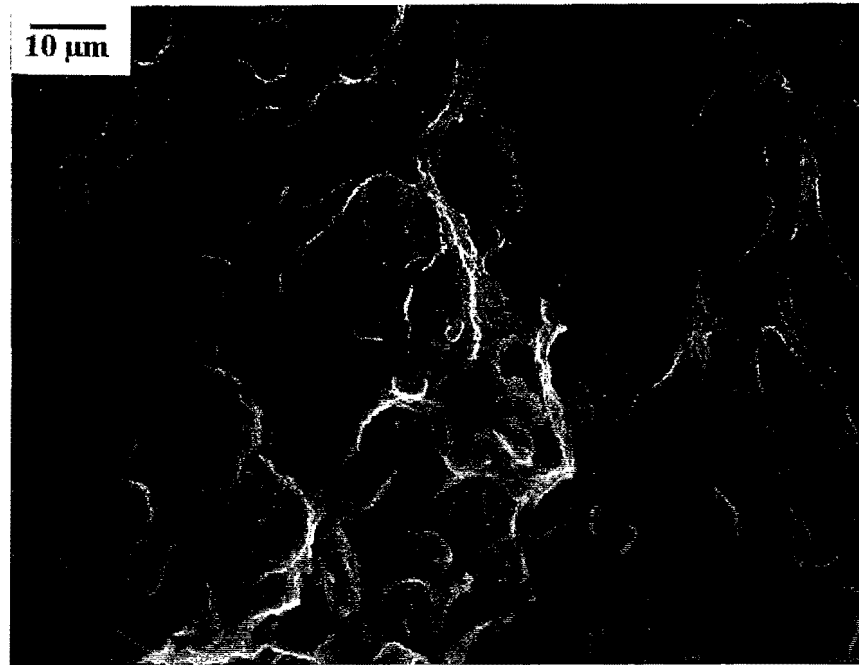
Fig. 4.38b. Optical micrograph at a higher magnification of the same specimen as in Figure 4.38a showing regions of ductile fracture and fatigue fracture.

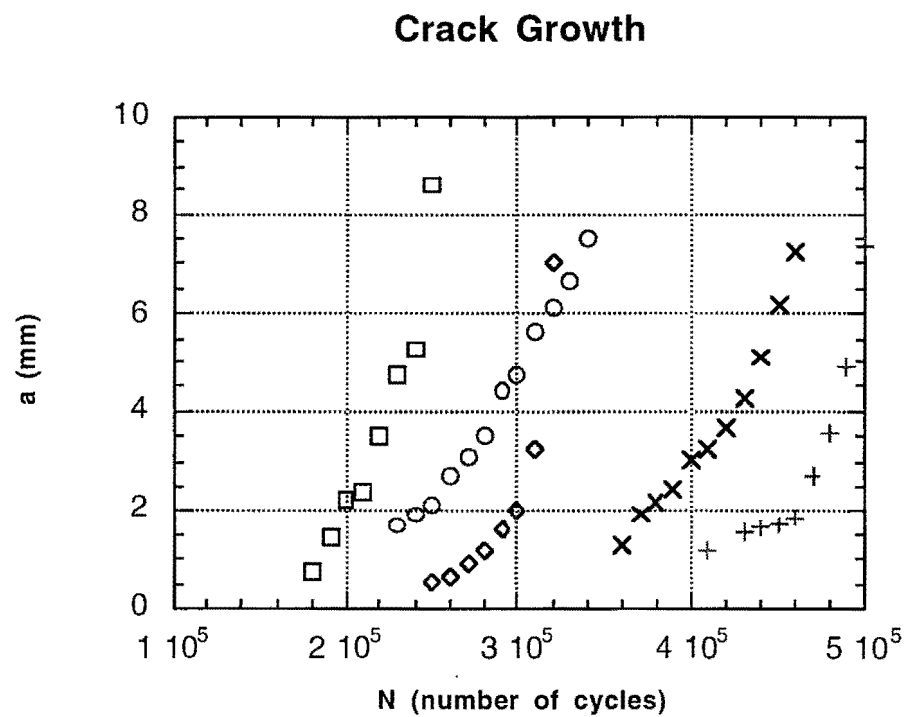
Fig. 5.1. Crack growth data on surface of five specimens fatigued at a maximum nominal stress of 103 MPa. Note the wide variation among specimens in the number of cycles until a growing macrocrack was first observed.

Originally, surface crack growth curves were obtained on specimens by in situ measurements of surface crack lengths at intervals in the fatigue cycling. This was accomplished using an optical microscope mounted onto the MTS machine. The surface crack growth curves for five specimens fatigued at a maximum nominal stress of 103 MPa are plotted as a vs. N in Figure 5.1. There was a wide variation in the number of cycles until the first propagating radial crack was seen. It occurred on one side of the specimen and then later occurred on the other side of the specimen. Its length when first seen was in the range of 0.5 mm to 1.7 mm. The variation in the number of cycles until a propagating crack was seen is ascribed to variations from specimen to specimen in machining the hole and in riveting. This was controlled more carefully than in industry, so more variation is expected in industry. The number of cycles between the first observation of rumpling and the first propagating radial crack

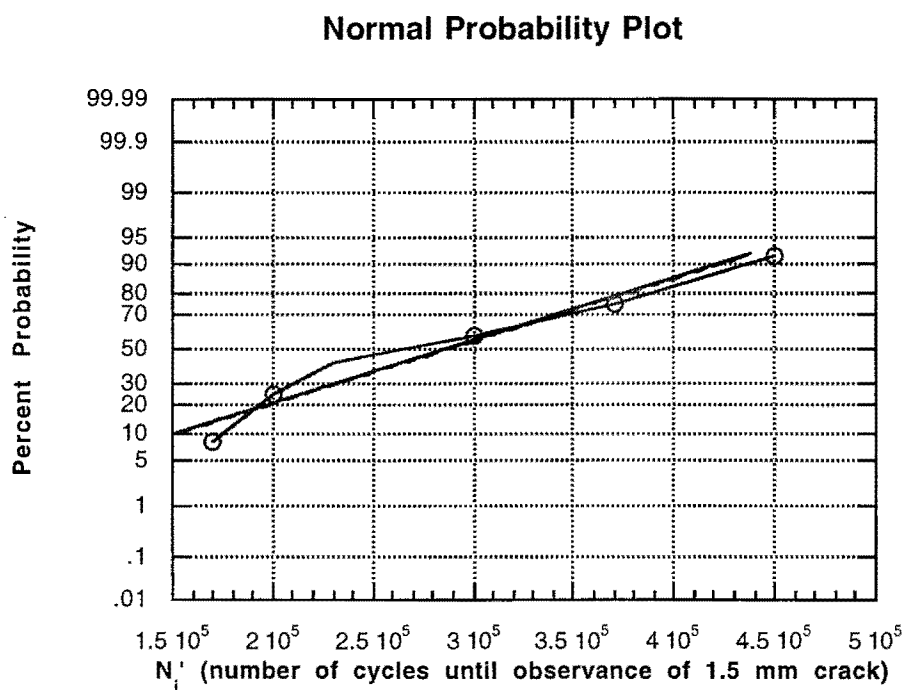
Fig. 5.2. Normal probability plot for the number of cycles until the observance of 1.5 mm crack on the surface. From this, the standard deviation is about 120,000 cycles.

were between 20,000 to 80,000 cycles. Observations were made every 10,000 cycles initially and more frequently after rumpling was observed. The normal probability plot given in Figure 5.2 shows a normal distribution and a standard deviation of about 120,000 cycles as estimated by taking the difference between the eighty-fourth the fiftieth percentiles.

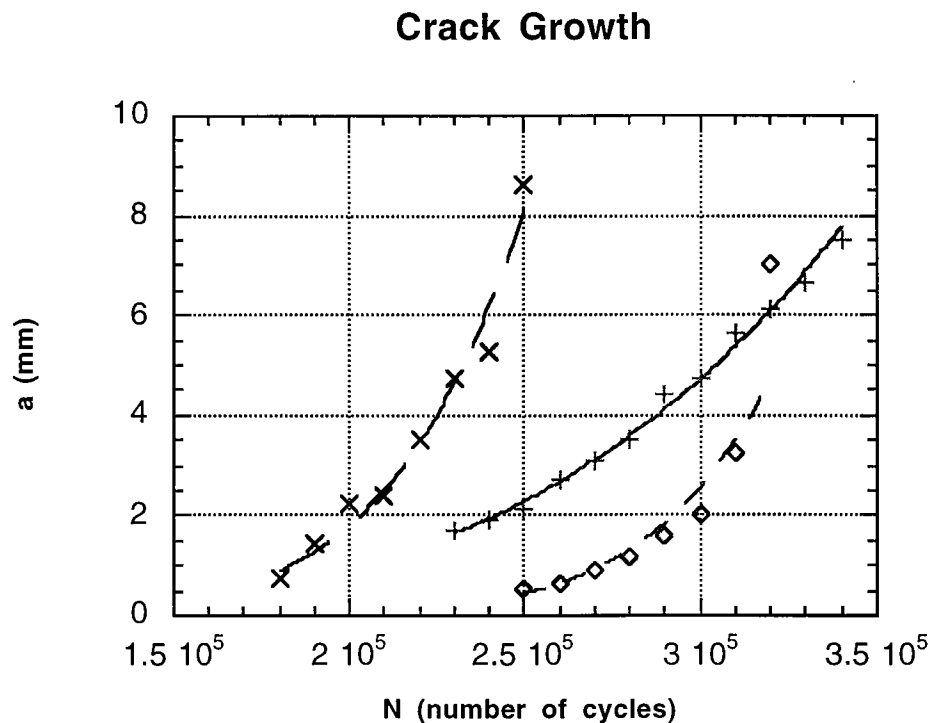
Fig. 5.3. Crack growth data of first three specimens fatigued at a maximum nominal stress of 103 MPa in Figure 5.1 on an expanded scale to better show initial crack growth.

Typical crack growth data for the first radial crack seen is exhibited in Figure 5.3 on an expanded scale for three specimens. The rate of growth increases with length increase as expected. There is an interval of approximately 20,000 to 60,000 cycles during which crack growth is slow and an opportunity exists for early crack detection. This occurs when the length of a , as defined in Figure 3.6, is less than about 3 mm.

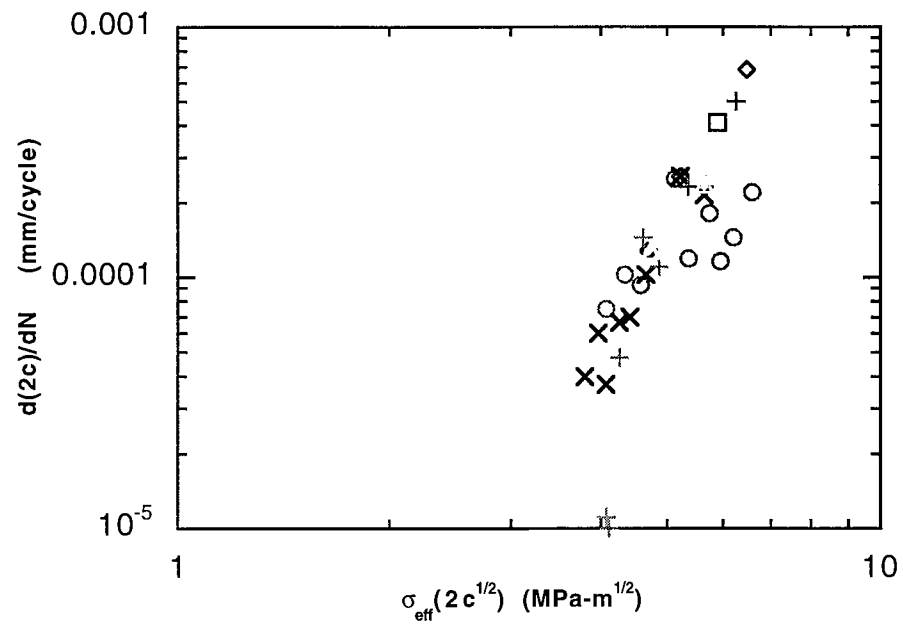
Fig. 5.5. Plot showing crack growth rate of end-to-end crack on both sides of the rivet as a function of the effective stress times square root of end-to-end crack length, $2c$. Specimens were fatigued at a maximum nominal stress of 103 MPa.

both sides of the rivet were seen. The range of $2c$ plotted is 6 mm to 20 mm. Macrocrack growth is divided into three regions: Region I is near threshold initial slow crack growth; Region II is power law growth; and Region III is unstable growth to final failure. In several specimens, the near threshold region of slow crack growth (Region I) was observed. Later a power law (Paris type) behavior indicative of Region II is suggested. Region III (unstable crack growth) occurs much later in the life of the specimen than plotted in the figure.

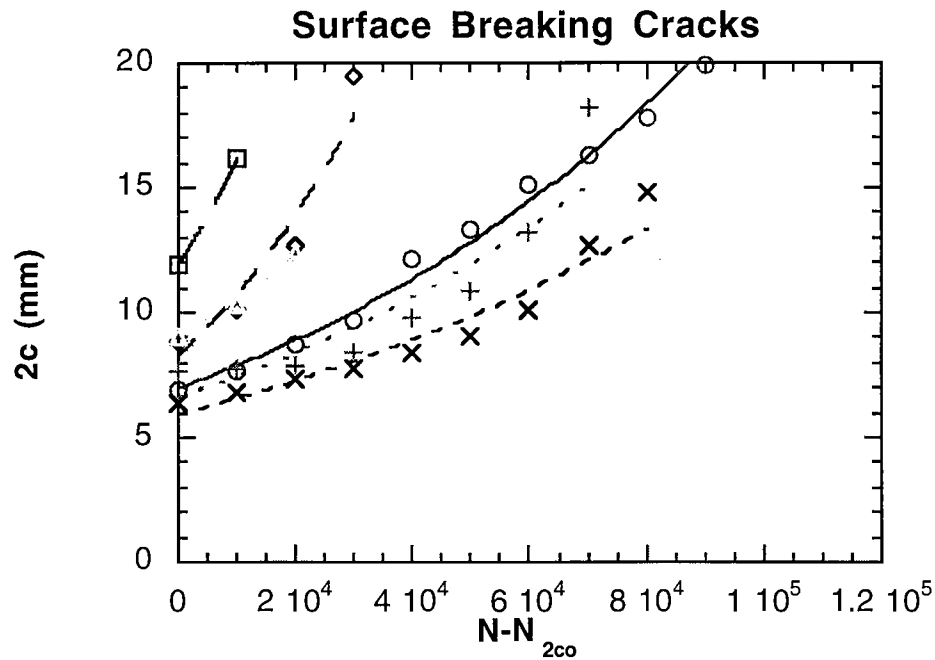
Fig. 5.6. Plot showing end to end surface crack growth vs. cycles in 6 specimens. N_{2co} is defined as the number of cycles until a crack of length $2c$ was first observed on the outer surface. $2c$ is defined in Figure 3.6. Specimens were fatigued at a maximum nominal stress of 103 MPa.

A series of experiments were done with different sets of specimens to better compare crack growth on the surface and in the interior. Defining N_{2co} as the number of cycles until a crack of length $2c$ was first observed on the outer surface, and N as the total number of cycles, a plot of the end-to-end crack length, $2c$, vs. $N - N_{2co}$, is given in Figure 5.6. Crack length, $2c$, is defined in Figure 3.6. While the rivet head is 6 mm in diameter for these eyebrow cracks, the chord is smaller than 6 mm. The variation in

length for $2c_0$ is partially due to the crack not always emerging next to the rivet head but some distance away and partially due to measurements being taken every 10,000 cycles so that the crack was not always detected as soon as it broke the surface. Using the acoustic microscope, the approximate number of cycles until a crack of length $2c$ was first seen in three specimens different from those in Figure 5.6 on which subsurface crack growth measurements were taken was defined as N_{2cs} . Using the same scale for the x and y axes as that in Figure 5.6, a plot of the subsurface crack length, $2c$, vs. $N - N_{2cs}$ is given in Figure 5.7. N_{2co} represents a more developed crack than N_{2cs} , because the crack is detected later on the surface than in the subsurface. At N_{2cs} no crack would be seen on the outer surface; however, at any give surface length the crack is longer on the subsurface. Comparing these two figures, it is obvious that the subsurface crack growth is much slower than the crack growth observed on the surface after the crack has broken the surface. Again, the measurements taken on these specimens were for *subsurface* crack lengths. $2c_s$ were between 6 and 8 mm when first detected. The fatigue tests were stopped prior to the cracks breaking the surface. Figure 5.8 is a plot of crack growth taken on three specimens *until failure* using the acoustic microscope. Data until about 17 mm is shown.

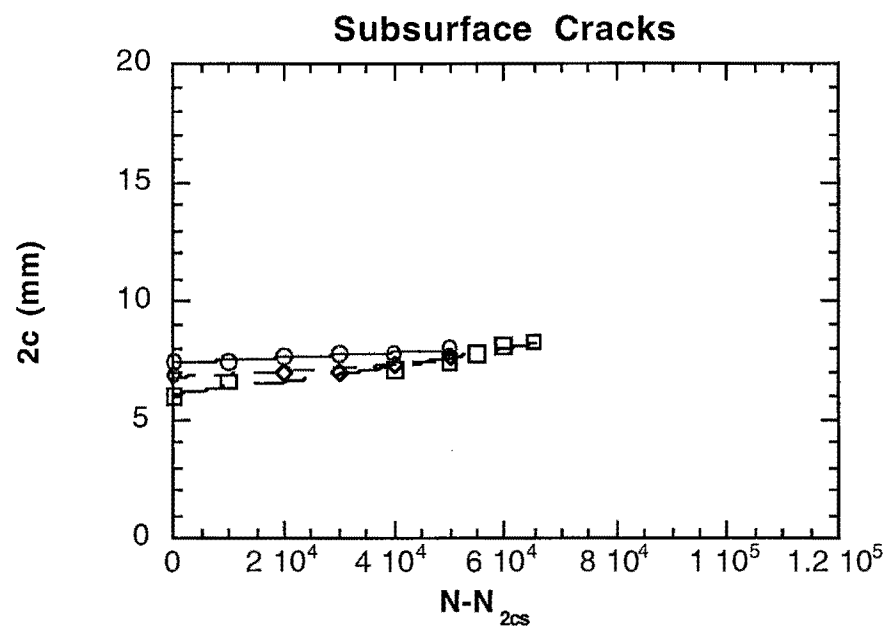
Fig. 5.7. Plot illustrating subsurface crack growth in three specimens different from those in Figure 5.6. Specimens were fatigued at a maximum nominal stress of 103 MPa.

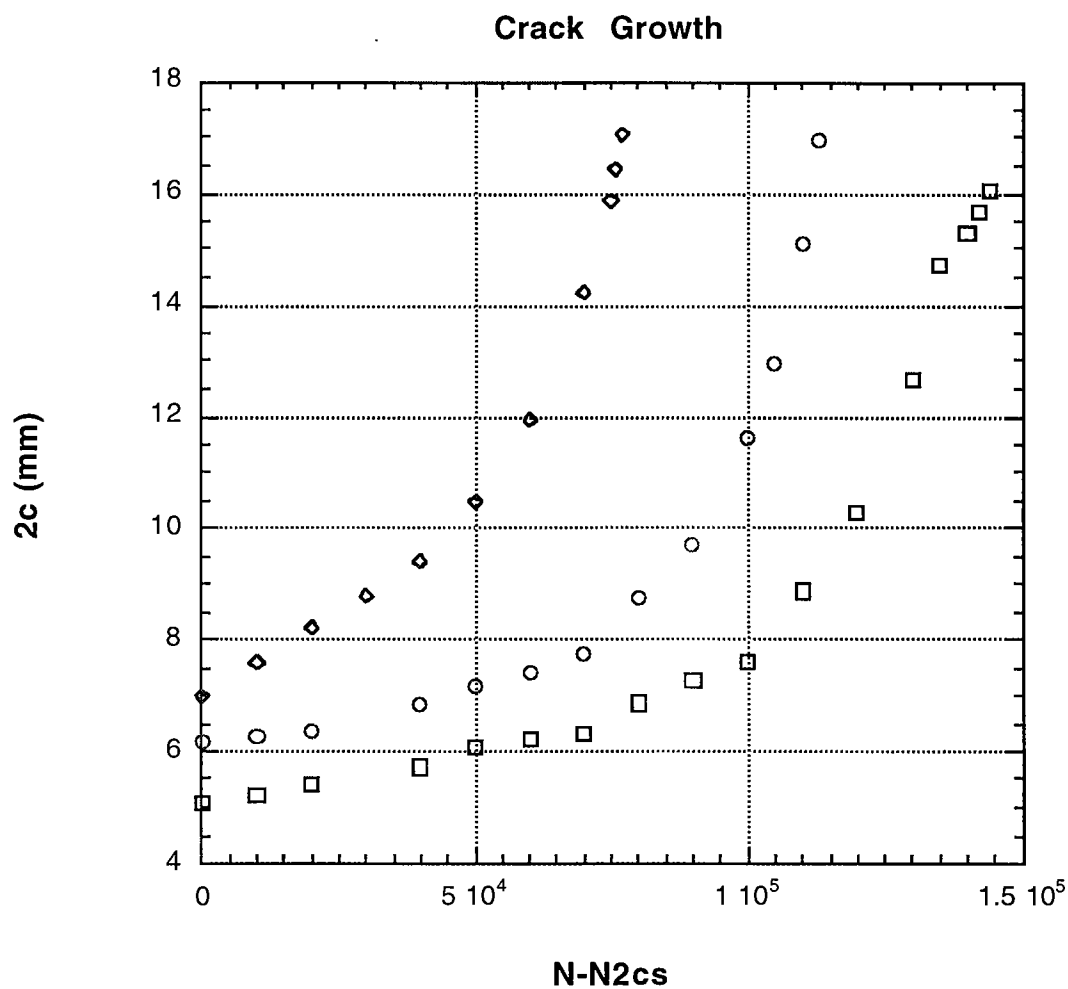
Fig. 5.8. Plot of crack growth for a maximum stress of 103 MPa as obtained with the SAM.

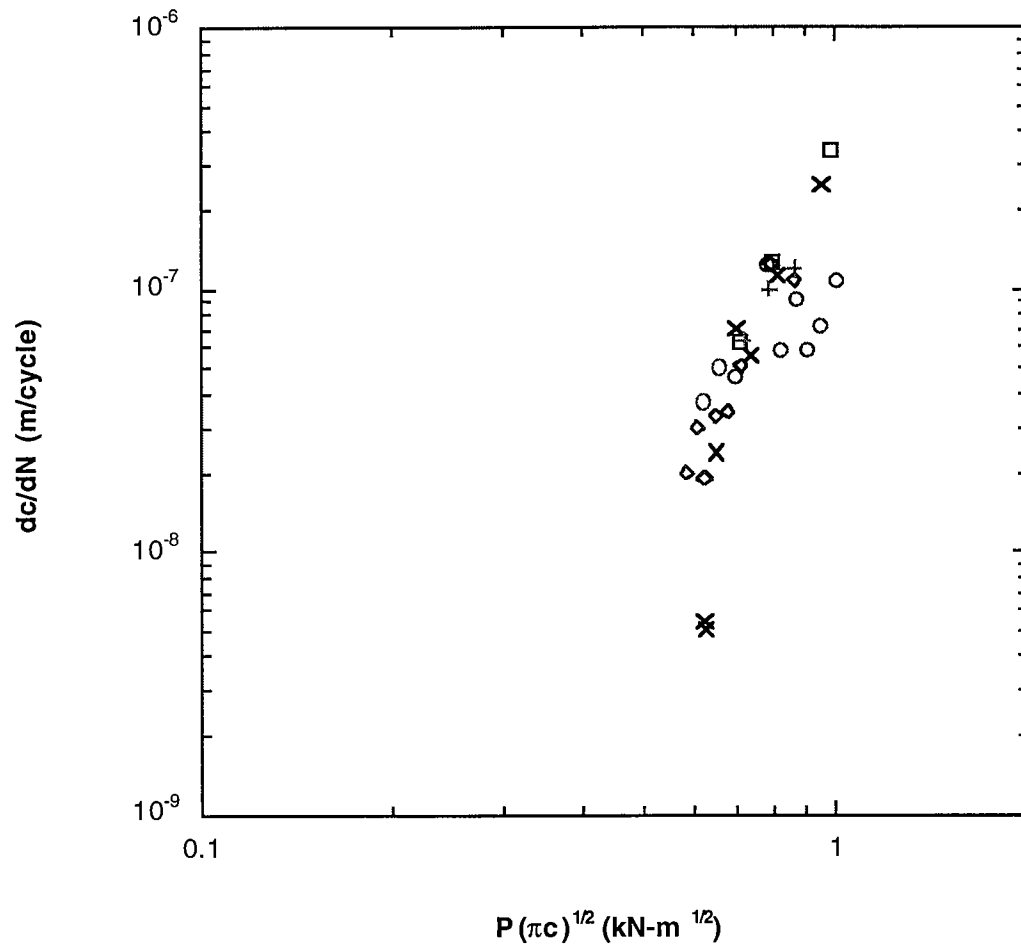
Fig. 5.9. Plot of dc/dN vs. $P(\pi c)^{1/2}$ for surface cracks that were measured using the optical microscope. Note these cracks are longer in the subsurface. Specimens fatigued at a maximum nominal stress of 103 MPa. dc/dN was determined from the crack growth curves, Figure 5.6.

In Figures 5.9 and 5.10, dc/dN vs. $P(\pi c)^{1/2}$ were plotted, where P is the maximum load and c is defined in Figure 3.6. dc/dN was determined from the crack

growth curves, Figures 5.6 and 5.7. The data plotted in Figure 5.10 are for shorter cracks than the data plotted in Figure 5.9. The plot of dc/dN vs. $P(\pi c)^{1/2}$ for growth of the crack on the surface is given in Figure 5.9 and for crack growth measured subsurface in Figure 5.10. Considerable variation from specimen to specimen is noted in the subsurface crack growth rate, and there is evidence for crack arrest and crack growth retardation as commonly observed with microcracks. [Newman, 1994; Newman et al., 1997; Newman et al., 1994; Newman et al., 1988; Kaynak and Ankara, 1992; Wanhill and Schra, 1990] This could mean that the cracks hit some sort of barriers which they had to pass through (grain boundaries, precipitates, inclusions, etc.).

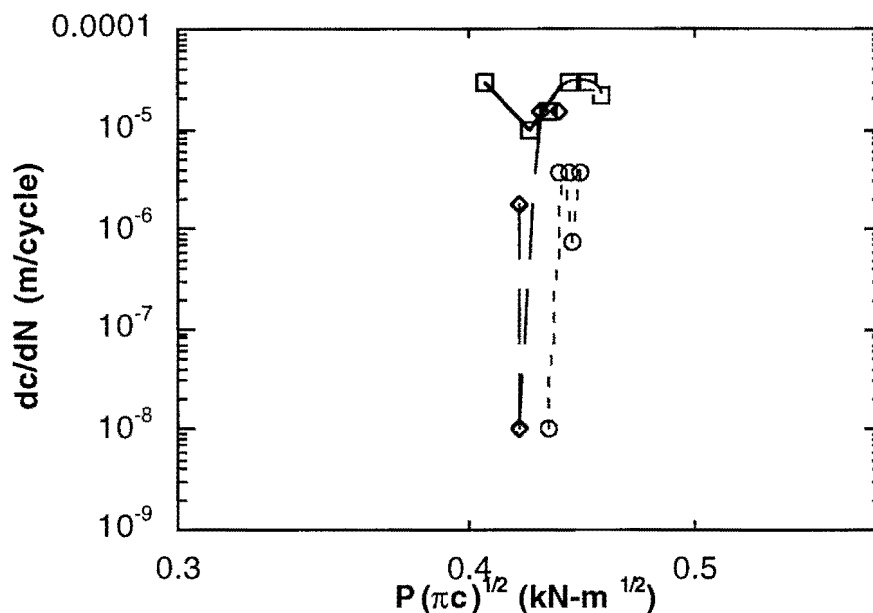
Fig. 5.10. Plot of dc/dN vs. $P(\pi c)^{1/2}$ for subsurface cracks that were measured using the scanning acoustic microscope. Note these cracks are longer in the subsurface. Specimens were fatigued at a maximum nominal stress of 103 MPa. dc/dN was determined from the crack growth curves, Figure 5.7

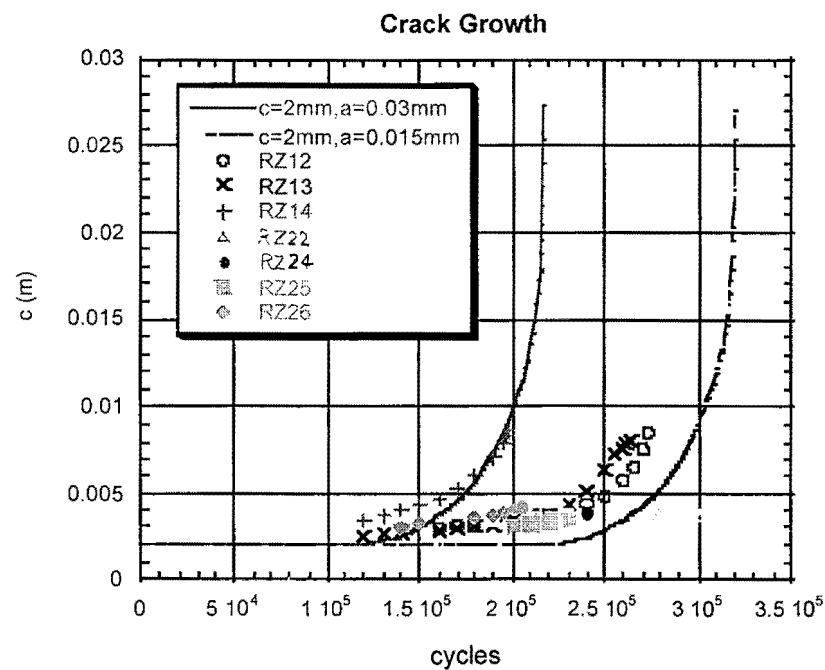
Fig. 5.11. Plot comparing crack length vs. number of cycles as obtained with the SAM and as acquired using FASTRAN-II analysis. Specimens were fatigued at a maximum nominal stress of 103 MPa. The solid and dashed lines are the FASTRAN-II predictions. As given in the language of the FASTRAN-II code, c is the half crack length and a_i is the initial flaw size.

(1995), he then formed baseline ΔK_{eff} -rate relations used in FASTRAN II. The plot in Figure 5.11 gives the results of the FASTRAN-II analysis, which was run and then compared with results obtained with the use of the acoustic microscope. In FASTRAN, there are 17 defined crack configurations from which to choose. The surface crack configuration was used as the crack initiates a slight distance from the rivet on the fayed surface at a maximum stress of 103 MPa. When a lapjoint configuration was used that assumes a corner crack at the knife edge, the curve was much sharper than the observed behavior. Different types of cyclic loads may be applied. Constant amplitude was selected as the type of cyclic load to match the experiments. For the surface crack configuration, an initial, c_i , half-crack length and an initial flaw size, a_i , was specified. This is the nomenclature used in the FASTRAN program. Literally, a is the crack height and c is the half-crack length. Using the nomenclature in the FASTRAN program, an initial crack size of 2 mm was used as an approximation of the half-crack length at initiation. This is about half the distance between the initiation sites for the cracks on each side of the rivet hole. As the cracks at this nominal stress initiate away from the rivet hole and there are several initiation sites on each side of the rivet hole this is a very rough approximation. Also, it is not likely that the initial crack length would be as large as 2 mm. Initial flaw sizes of 15 μm and 30 μm were selected. Again this is not exactly representative of the types of

cracks that develop in the lap joint, because this assumes that there is only one initial flaw of height, a , when in actuality there are several initiation sites on each side of the rivet hole. The initial flaw size and initial crack size selected in conjunction with the type of load and crack configuration selected were made to give the best fit.

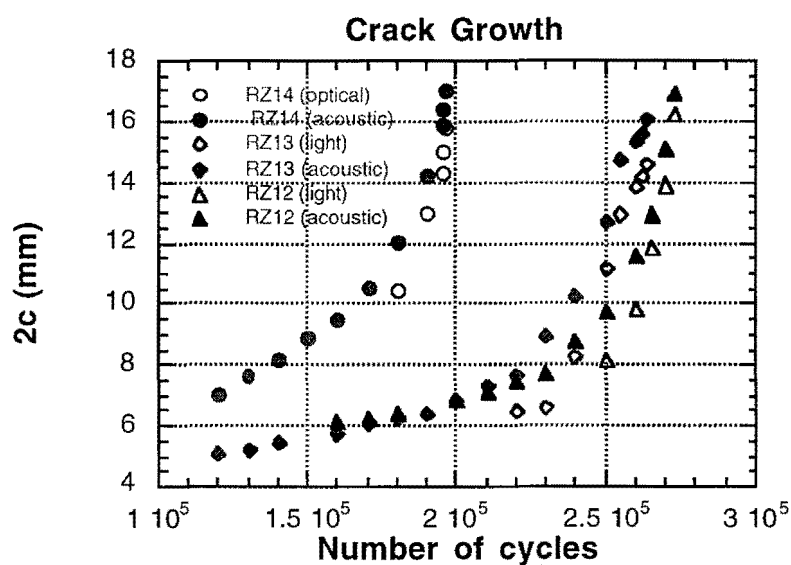
Maximum stress of 103 MPa

Fig. 5.12. Plot of the crack growth of specimens fatigued at a maximum stress of 103 MPa as measured with the optical microscope and with the SAM. The closed symbols are SAM measurements and the open symbols are optical measurements.

The previous data taken with the optical microscope and with the acoustic microscope were on different specimens. Therefore, it was desirable to measure both on the same specimens. This was done for specimens fatigued at 154 MPa maximum nominal applied stress and for specimens fatigued at 103 MPa maximum nominal applied stress. Figure 5.12 is a plot of the crack growth of specimens fatigued at a maximum stress of 103 MPa and measured with the optical microscope and with the SAM. [Connor et al., 1998]. The first data points plotted are the numbers of cycles to when cracks were first observed with the SAM on both sides of the rivets. Recall the rivet head diameter is 6 mm. The chord length is included in $2c$ and this increases as the crack reorients to become a normal crack. This plot shows slow, almost linear subsurface crack growth vs. time, but when the crack breaks through the outer surface, i.e. becoming a through crack, the crack growth rate increases rapidly. The surface crack lengths that were studied optically were consistently shorter than the measured values with the acoustic microscope (showing that the crack is longer on the inner surface of the specimens). Cracks were observed on average approximately 80,000 cycles earlier and at about a 2 mm shorter crack length, $2c$, using the scanning acoustic microscope than by careful microscopic examination of the chamfered panel outside

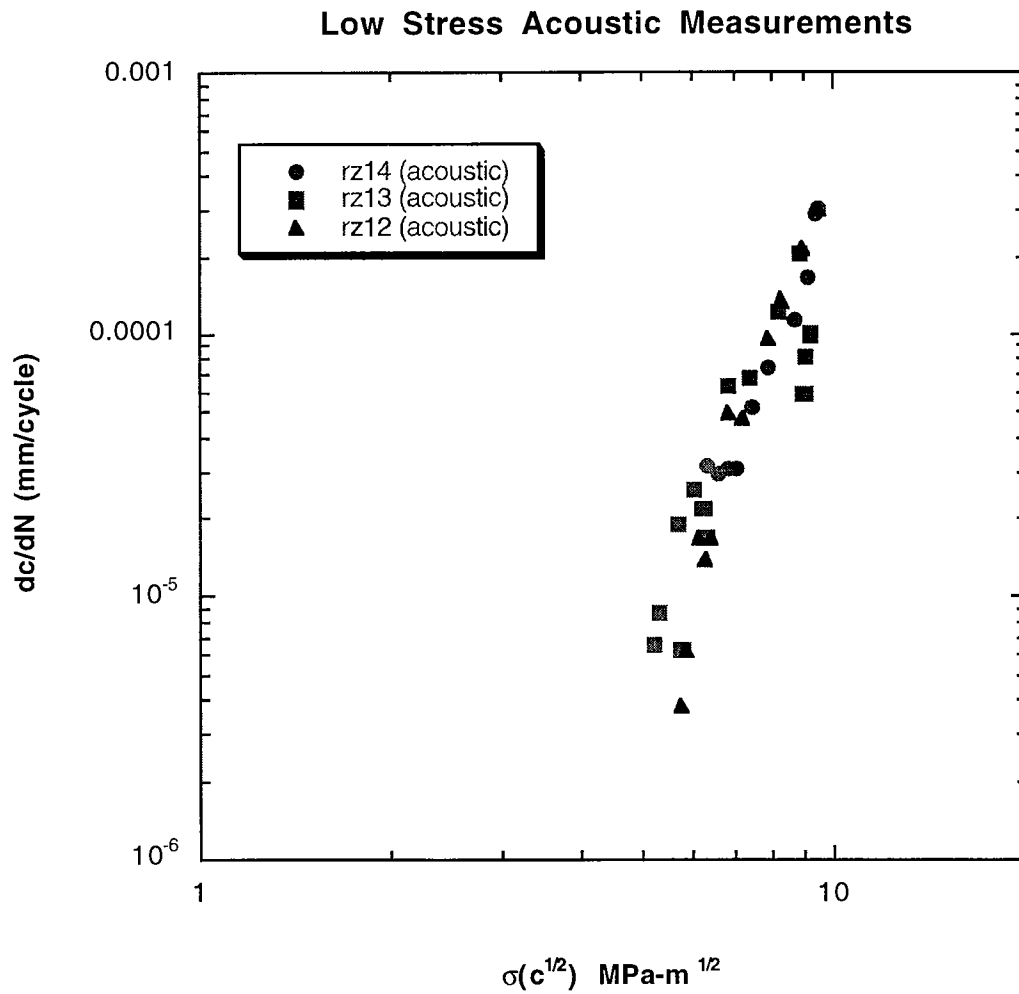
Fig. 5.13. Plot of dc/dN vs. $\sigma(c)^{1/2}$ at a maximum load of 4 kN as obtained with the acoustic microscope. Specimens were fatigued at a maximum nominal stress of 103 MPa. dc/dN was determined from the acoustic microscope crack growth curves, Figure 5.12

surface. In Figure 5.13, dc/dN vs. $\sigma(c)^{1/2}$ was plotted, where σ is the maximum nominal applied stress and c is defined in Figure 3.6. dc/dN was determined from the crack growth curves, Figure 5.12. From the Paris region of this plot, the value for the exponent, m , is found to be approximately between 3.8 and 4.2. This approximation compares with an m value, 3, in 2024 Al-T4 as reported by Liaw et al. (1981).
